Emergency Sea Access Stair Replacement

Stair Replacement

PROJECT PROFILE

AME Pty Ltd was contracted by Icon Engineering to provide project planning and site supervision services for the replacement of the emergency sea access stairs onboard the Ocean Bounty.

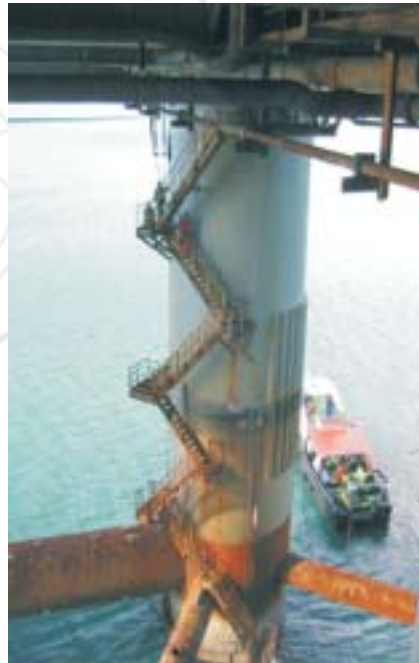
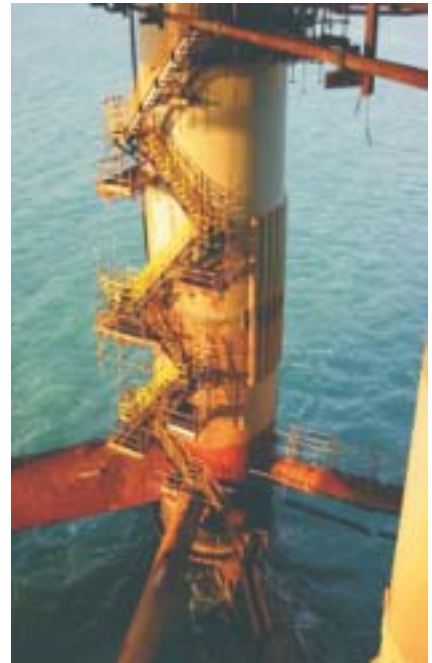
Sea Access Stairs before removal of old (left) and during weld-out of new (right).

The sea access stairs were positioned under the deck of the rig, and therefore it was not possible to directly use rig crane to remove loads. Removal and replacement of the stairs was therefore carried out using a combination of a remotely positioned winch and static rigging. The rig crane was used to lower stair components over the side of the rig, where they were transferred to static rigging.

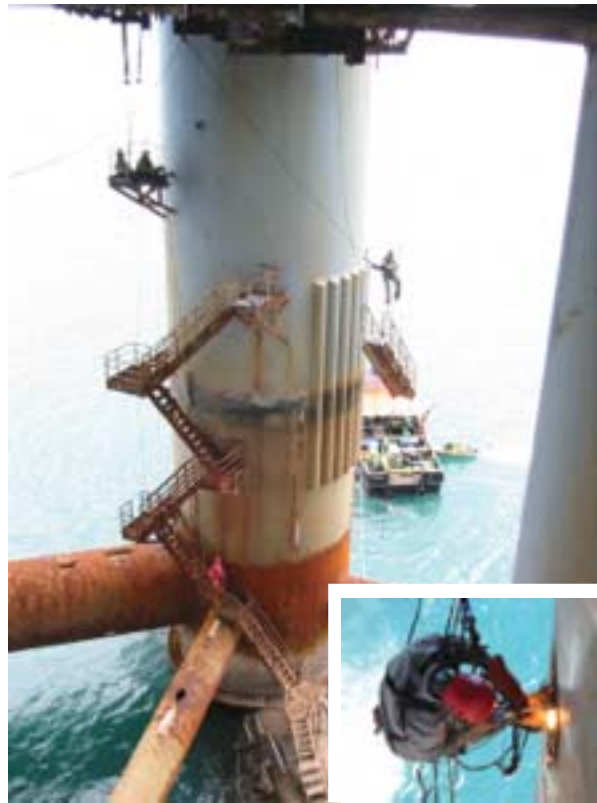
Each stair section was supported on static rigging that was hung from a hard point above. The winch wire was connected to the load and then the load was cut free from the main structure. The stair section was then lowered onto the winch wire, and the static rigging was removed. A stinger on the crane whipline, was then lowered adjacent to the jobsite. The winch was payed out to lower the stair section until the crane stinger could be attached. The load was then transferred to the crane, and the winch wire was removed (Photo 1). Following removal of all stair sections, all installation locations were prepped for the installation of new steelwork. (Photo 1 - Inset).

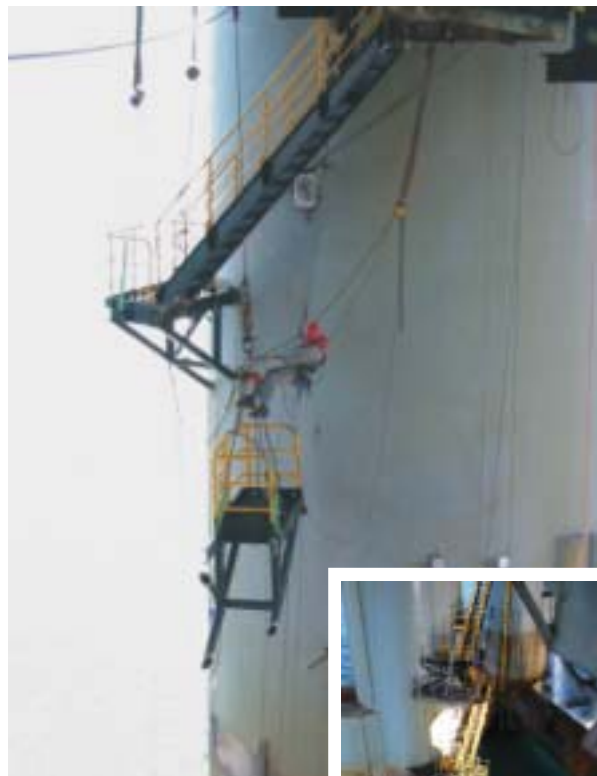
Installation of new steelwork was achieved using the reverse of the demolition procedure (Photo 2). The new stairway was installed in 16 separate pieces. Each unit weighed between 800 and 1100 kgs.

Once all steelwork was positioned and tacked, scaffolding was erected for the weld-out, NDT and painting phases. (Photo 2 - Inset)
