Rope Access Coating Repairs

PROJECT PROFILE

Client:	McConnell Dowell Barclay Mowlem JV
Location:	HI Wharf Extension Dampier, WA
Project Duration:	9 months
Date:	Oct 2005 - Jul 2006
Crew Size:	6

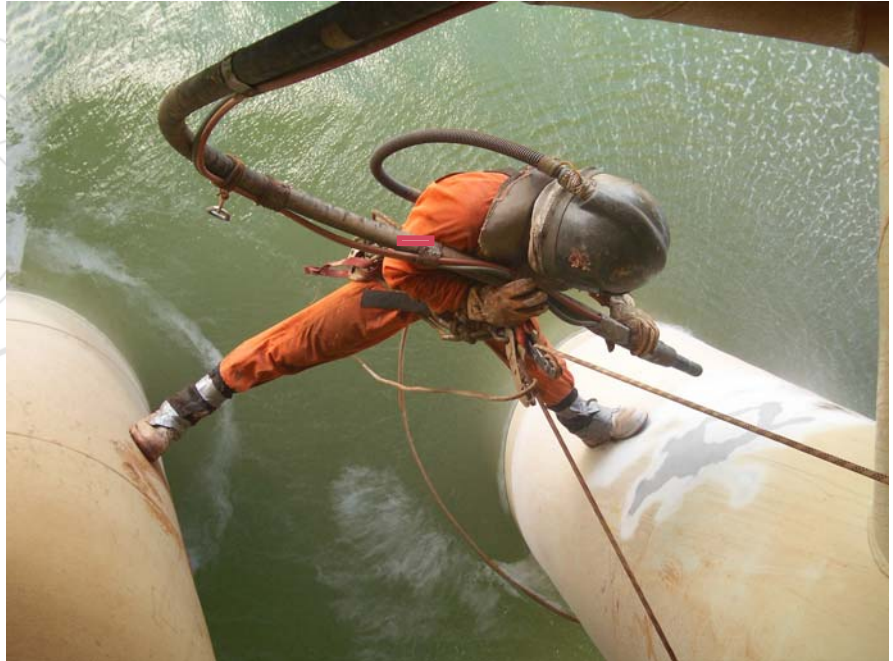
Abrasive blasting for
spot repairs to
damaged wharf piles.

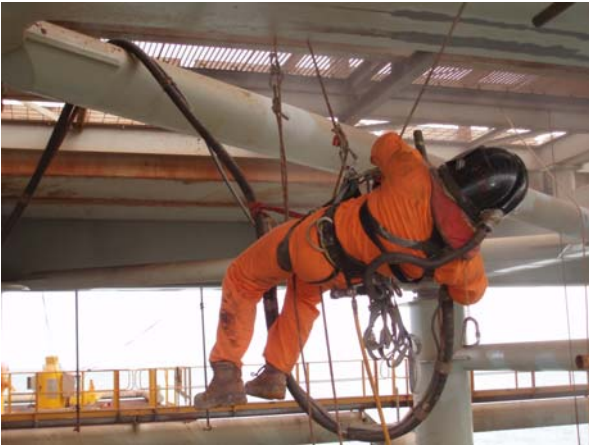
(a)

Photo (a): Abrasive grit blasting on underside of wharf structural members.

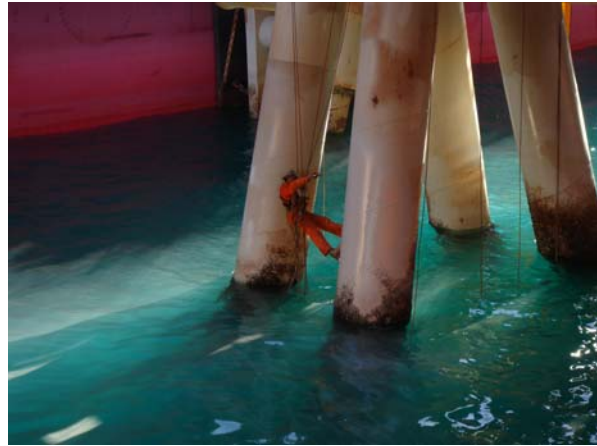
(b)

Photo (b): Airless spray painting of wharf piles being carried out with no disruption to normal ship loading activities (note ore carrier in the background.)

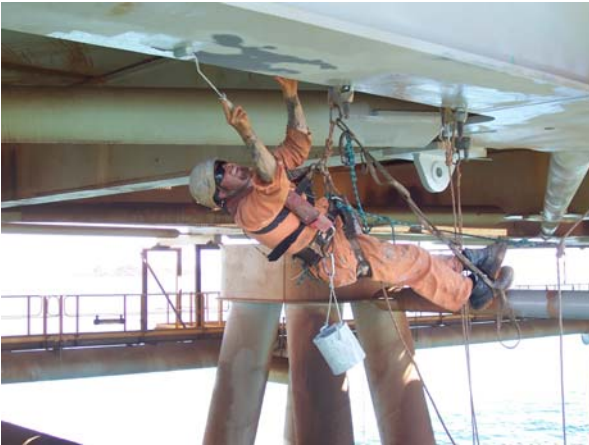
(c)

Photo (c): Spot repairs to coating system.

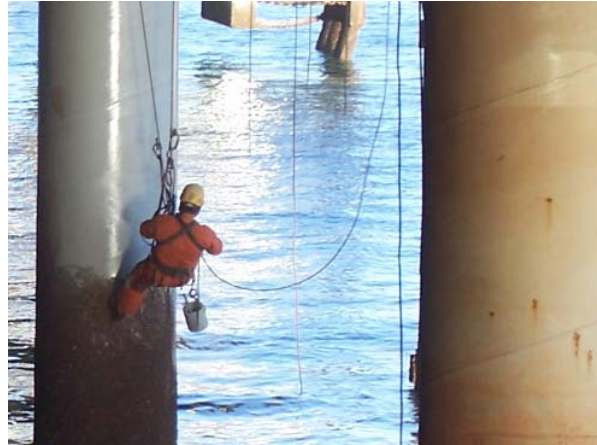
(d)

Photo (d): Dry Film Thickness (DFT) testing of completed paint repairs was also undertaken using rope access.
